colorado affordable housing Cottonwood Case Study | Windsor, CO

Project data

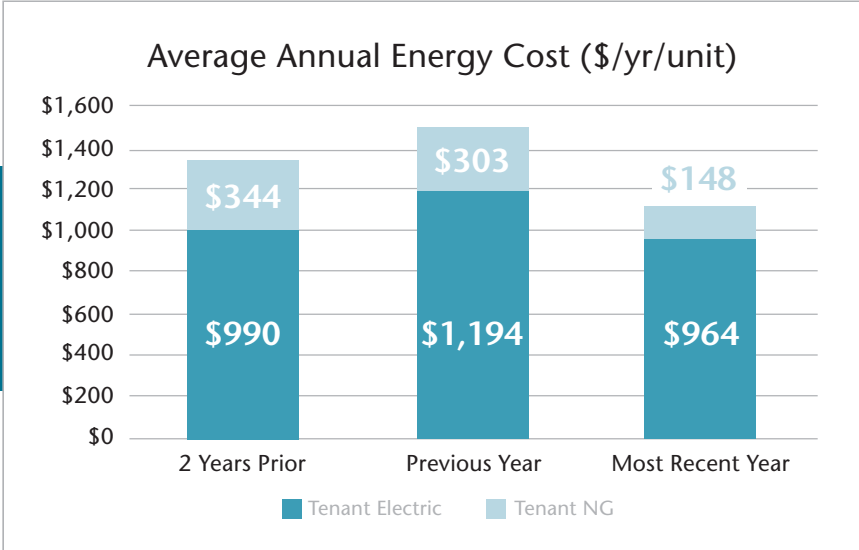
Annual utility costs saw a slight decrease compared to the full year preceding the heat pump installation. While electricity costs remained relatively stable with a 3 percent decrease, natural gas costs dropped by 57 percent, leading to a total utility savings of 17 percent. The impact on Energy Use Intensity, measured in kBtu per square foot per year (kBtu/SF/yr), was even more pronounced. Prior to the retrofit, the building's EUI stood at 41.8 kBtu/SF. Following the heat pump installation, this figure dropped to 22.3 kBtu/SF, a reduction of 47 percent in EUI.

Following twelve months of operation, a utility analysis was conducted to evaluate pre- and post-renovation energy consumption, operational costs, and energy use intensity (EUI). The analysis was performed for a sample of eight units with authorized access to utility data. Overall, both operational costs and EUI decreased. As anticipated, electricity consumption increased modestly, while natural gas consumption declined significantly.
